## Liquefaction potential map for Chimbote, Peru

J.E. Alva-Hurtado & D. Parra-Murrugarra

*CISMID, National University of Engineering, Lima, Peru*

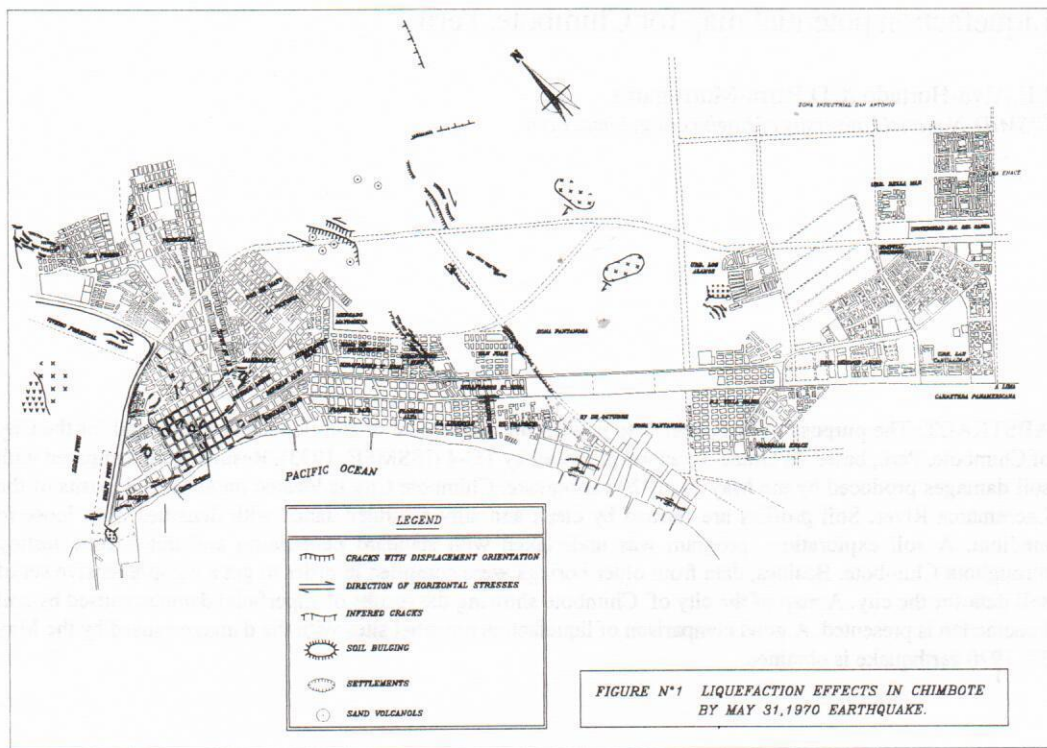
Morimoto et al (1971) described soil liquefaction in Chimbote and presented a distribution map of ground cracks and sand volcanoes (Fig N°1). In the backswamps and lowlands in alluvial deposit, general liquefaction was developed with cracks due to differential compaction of soil deposits. In the alluvial deposit, subsurface liquefaction developed, generating cracks with sand volcanoes and damage to wells.

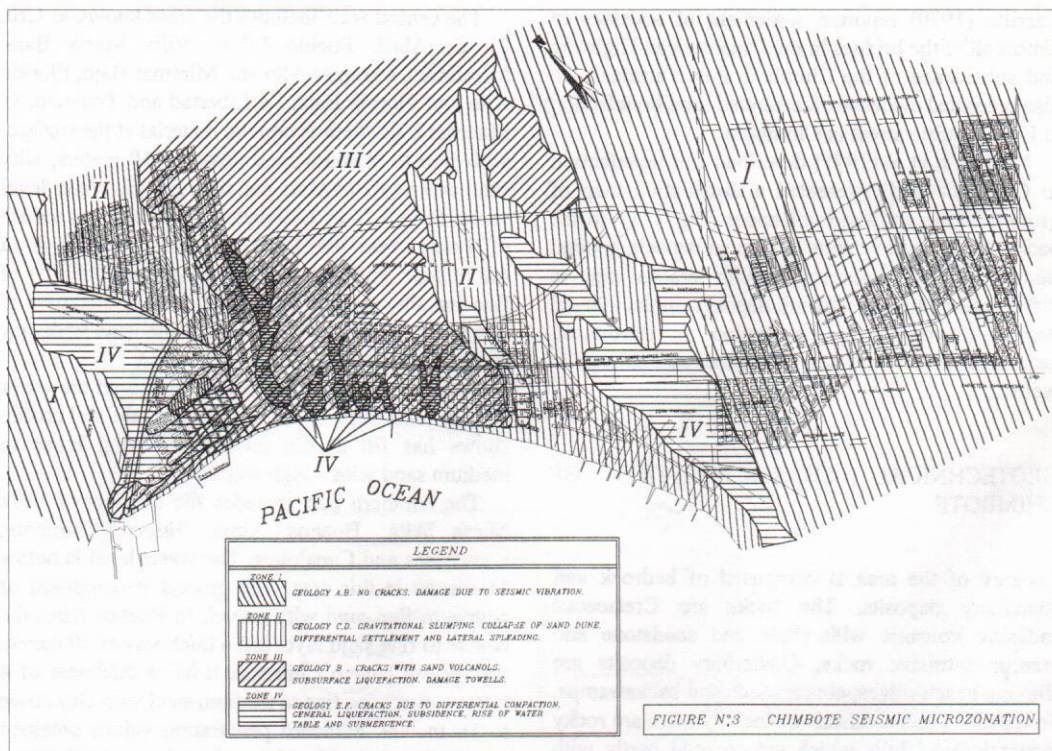
Seismic microzonation of Chimbote was undertaken by Morimoto et al (1971) based upon geology, standard penetration testing, damage evaluation, aftershocks and microtremors, seismic refraction and soil amplification studies. Four different zones were established (Fig N°3).

**Zone I.** The ground consists of dense gravel or rock with the water level at least 10 meters below ground surface. The elevation of the ground is above 10 m.a.s.l. Subsidence of buildings or ground is not expected. Larger seismic forces are expected in this zone because of soil structure interaction.

**Zone II.** This area is covered by loose to medium sand several meters thick. Below there is either dense sand or cemented sand. Water level is about 5 meters below surface. No settlement is expected for two-story buildings, except those at the outer edge of sand dunes. It is recommended that buildings higher than

Zone III. The soil profile is formed by sandy soil covered by thin agricultural soil. Gravel is found below 10 meters, with a shallow water level. Loose fine sand existing at different depths may liquefy during earthquakes. However no appreciable settlements will occur in building, except special cases.

Zone IV. This zone has a high water table. Most of the land is covered with water or swamps. Average elevation of the land is lower than 5 m.a.s.l. The soil profile consists mainly of sand covered with a very thin layer of organic silt. Damage to buildings is mainly by settlement and partly by seismic force. Liquefaction of the sand up to the surface will be produced by a severe earthquake. Pile foundations down to dense sand or improvement of the ground conditions, are recommended.

two stories be supported by piles reaching the dense sand. Construction on sand dunes must be improved with vibroflotation.

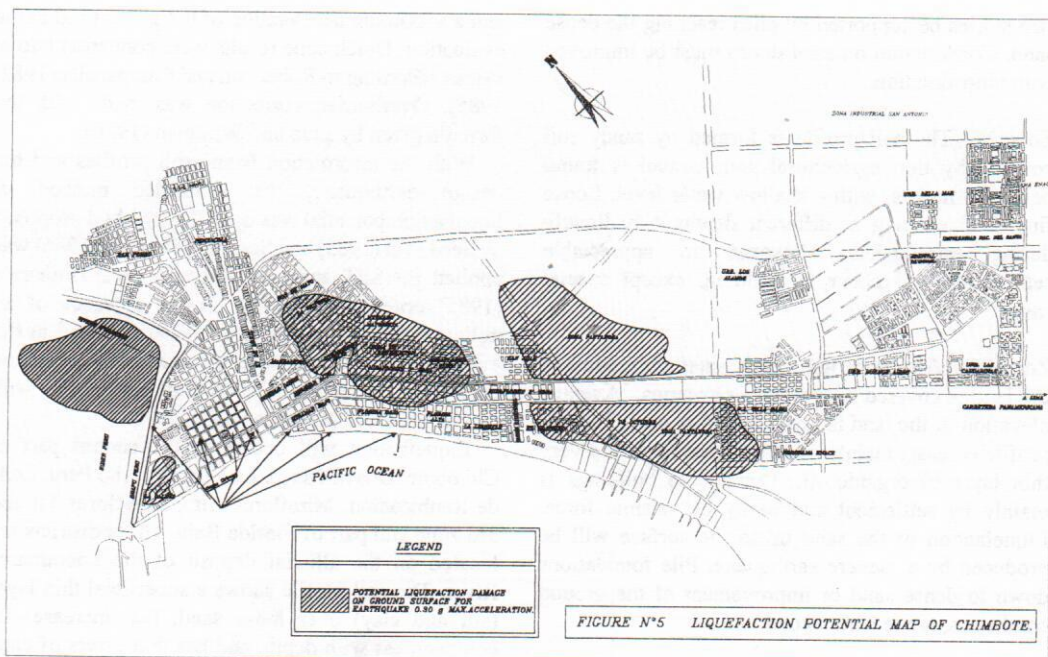
FIGURE N°5 LIQUEFACTION POTENTIAL MAP OF CHIMBOTE.

Liquefaction will occur in the central part of Chimbote: Dos de Mayo, La Victoria, Alto Peru, Zona de Reubicación, Miraflores Alto, Miraflores 1st and 3rd zone and part of Florida Baja. These districts are located on the alluvial deposit of the Lacramarca River. The soil profile shows a superficial thin layer (silt and clay) over loose sand, that increases its compactness with depth, and has thin layers of clay. Water level is at the surface. Liquefaction will also occur in the districts of San Juan, Urb. Trapecio, Barrio Magisterial in the south and in part of Miraflores 2nd zone. These sites are of loose eolian sand at the surface, increasing in density with depth. Water level is at 1.5 to 2.0 meters. In the northern part, Miramar Bajo and La Caleta districts, the phenomena of liquefaction will occur. The soil profile shows fine and silty sands with a high water level. The backswamp zone that exists to the north and to the south of Chimbote will also liquefy.

Fig N°5 presents a map of Chimbote showing the results of the liquefaction potential evaluation. Comparison of liquefaction potential sites with damage caused by the May 31, 1970 earthquake, as presented in Fig N°1, shows good correlation.
